## SNAG MY PROPERTY

### Property Snagging Overview Report

<b>Property address</b>	A Property Sample
<b>Client/Purchaser</b>	A Client

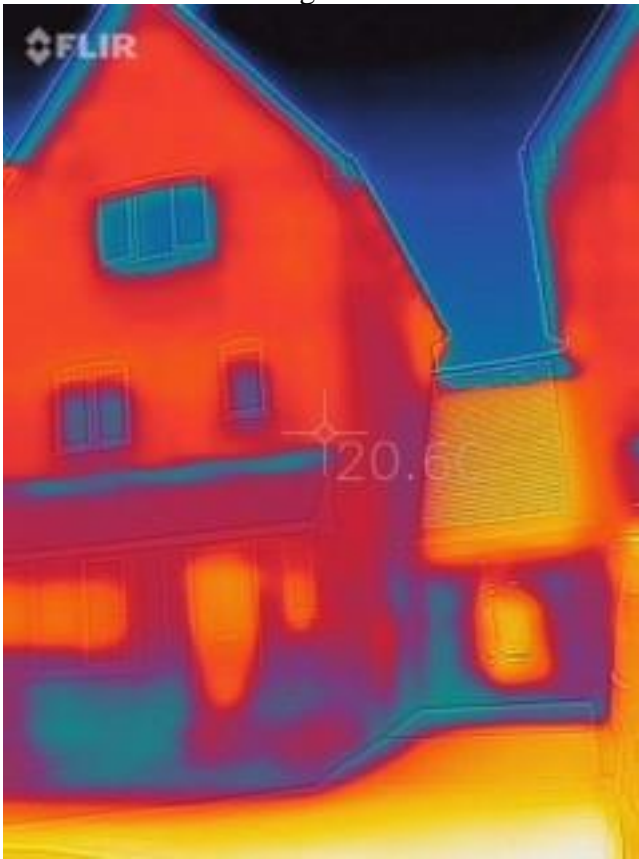
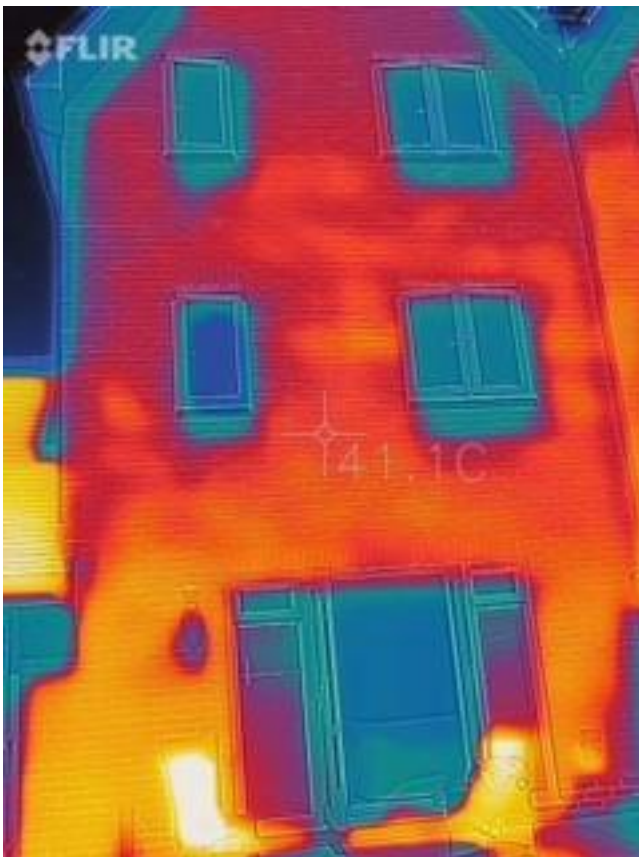
Front house-insulation good

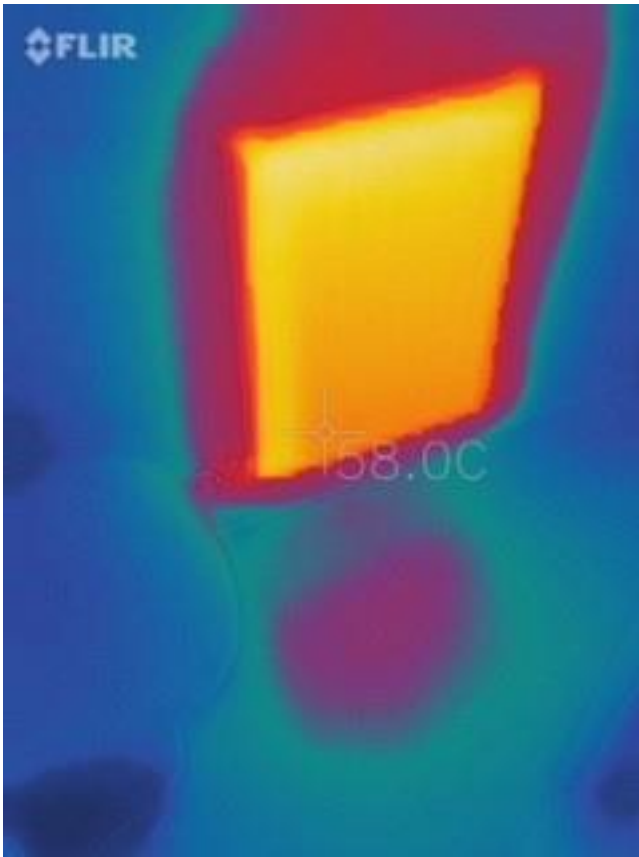
Utility radiator working well

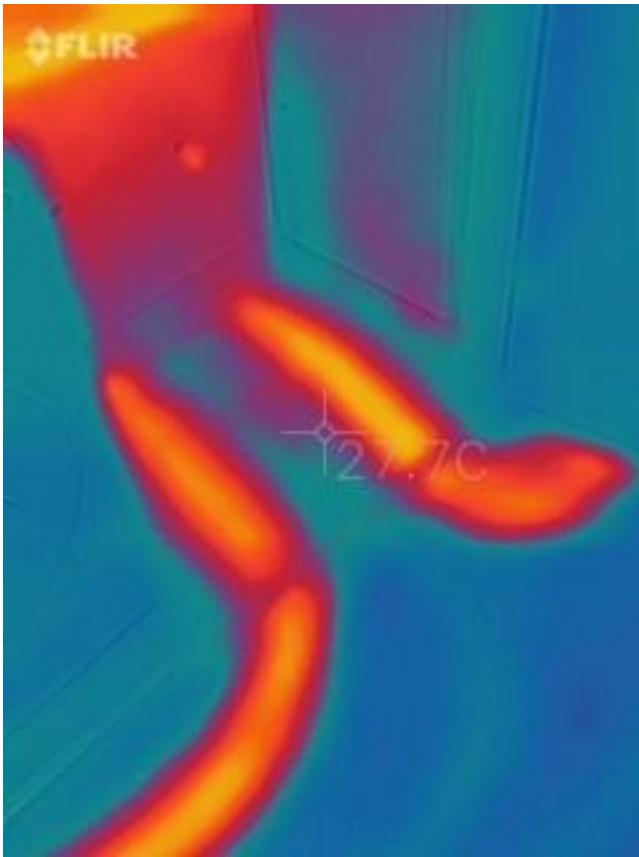
<b>Summary</b>	Thermal imaging showing radiator performance. Insulation is missing in kitchen wall areas as seen on thermal imaging and draught excluder and insulation required to front door and surrounding area. See thermal images below. General finish required as snag list and sparkle clean after works to handover.

Kitchen underfloor heating working well. Poor insulation under window showing.

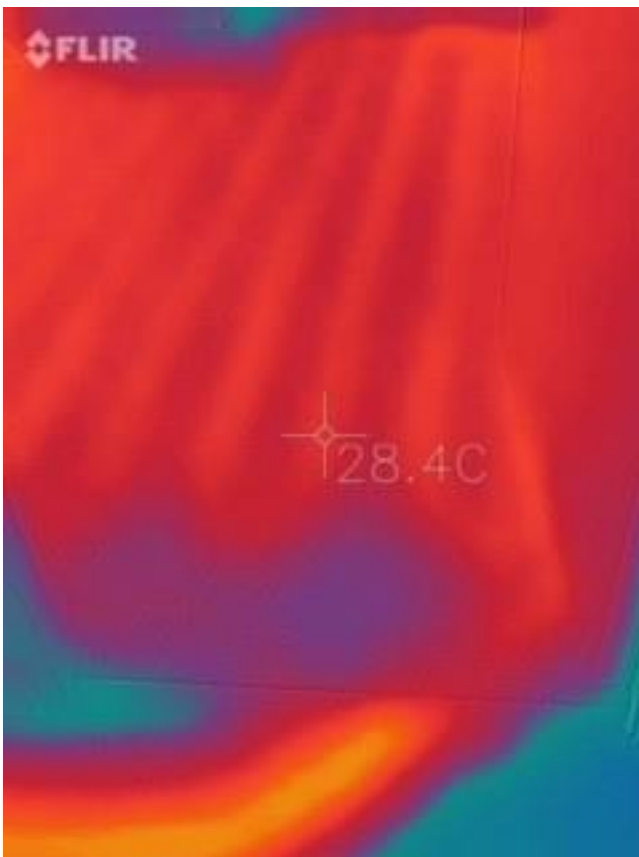
Hallway underfloor feed from boiler working well

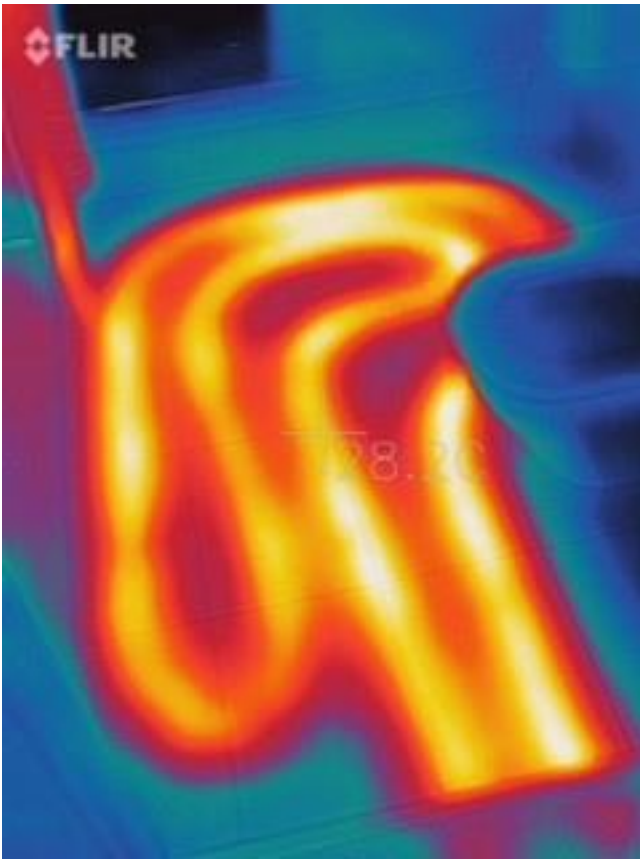
Lounge underfloor heating fully working

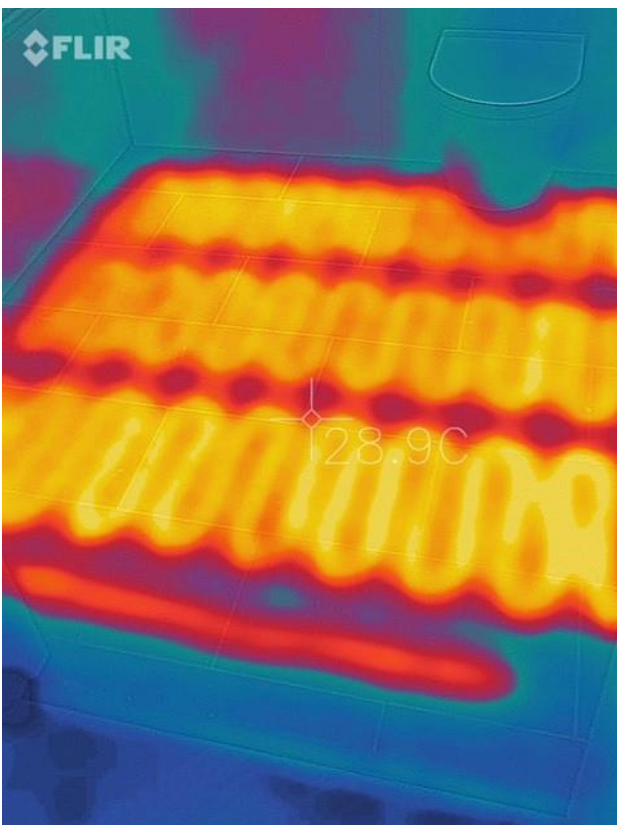
Bathroom underfloor heating working well

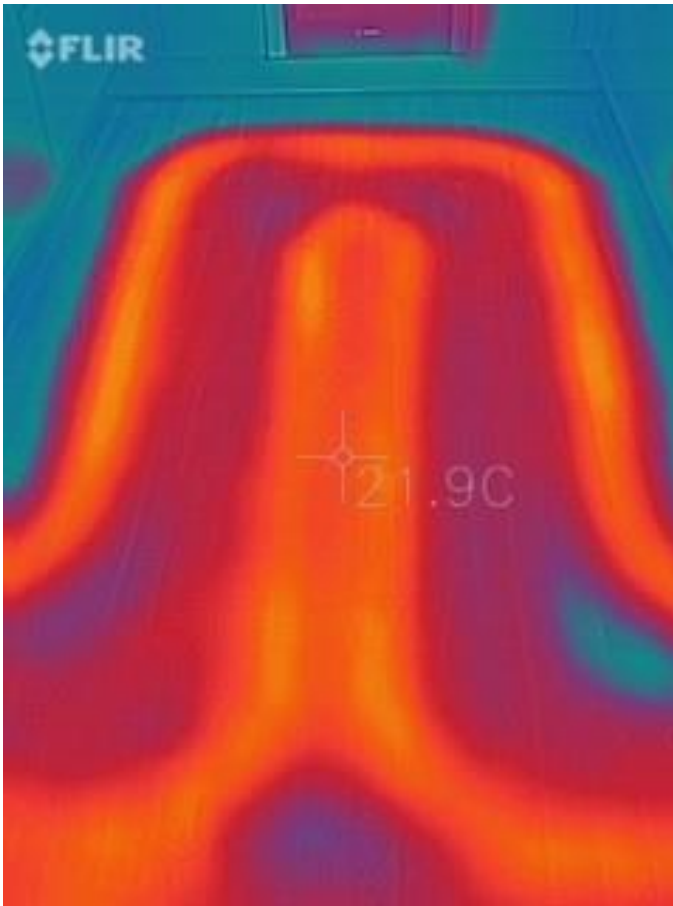
Master bedroom underfloor fully working
